Impact of Silt Excavation on River Morphology and Bed Material: A Study of Tarali Channel, Maharashtra, India

Jagdish B. Sapkale

Abstract :- River channels, being the container of the moving water and also the product of the movement of the same, become the most dynamic component of a river basin. Variations in the discharges reflect the variations in energy available and hence such variations immediately get reflected in the alterations in the channel morphology. Bank-full discharges are often considered to be the channel forming discharges. However, it does not mean that the flows below this condition do not have any role in shaping the channels. The changes caused by the discharge variations can be understood through the detailed study of the channel morphology. Any variation in the discharge is immediately reflected in channel geometry both in plan and profile. This is particularly true for the segment of channel, which is characteristically 'mobile' in nature, as the erodible materials often respond to flow variations with slightest provocation. In the present day context, an intervention in natural processes at varied levels by man has also resulted in serious ramifications

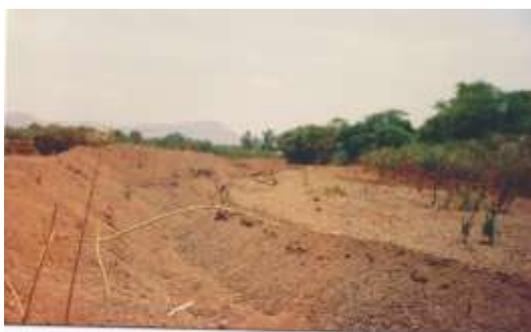
Plate 1: Trench was dug on the left bar to shift the channel

Some parts fine material is spread over the coarser material in the bed. Generally next to half portion of this stretch for 1st two years, the flow of river water was along the right bank for a distance of 270 m, then it shifted to left, during the year 1997, more shifting of river occurs in right side for maximum distance of 24 m. The same location also indicates the formation of large bar along the left side as a result of vegetation. During 1996, on the middle portion of the same Bar a continuous trench was dug (plate 1) up to a depth of 6-8 metres for a length of 200 metres in the left side of the channel by local people. As per their perception they tried to shift the channel forcefully towards its left in next year. But their efforts failed, channel shifted to its

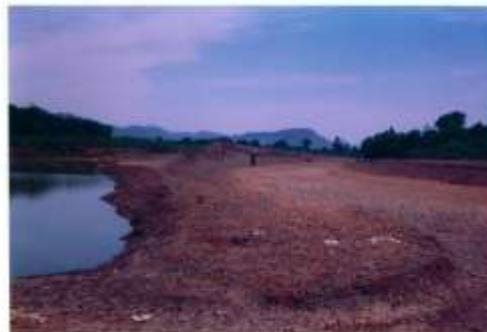
Plate 2: Deposition on the bar and lowering of bed in the right due to trench

right instead of the left side. This resulted in increase of the height of the bar by 1 metre due to the deposition of small sized material for a diameter of 0.5 to 2 cm with coarser and fine sand on the bar. During the survey period of 2002 such type of practices were highly responsible for the lowering (plate 2) of bed to another side of the bar. Opposite to this bar it appears to be the continuous alluvium extraction along right bank, extending for a distance of 150 m from the river. Sign of silt deposition for 0.8 m in Jan 96 has also been observed. Between CS 55-60 a large meander shift was expected to its right during Apr 96 and was marked in the map of Apr 95. But channel was shifted with a small meander for 7-8 m to its right. The encroachment of channel to its expected location may be encountered due to the shevari plantation and dumping of sand bags (plate 3) near CS 51. But during Jun 97 the channel entered in the right excavated block and shifted for 60 metres towards its right as per the expected channel, marked in Apr 95.

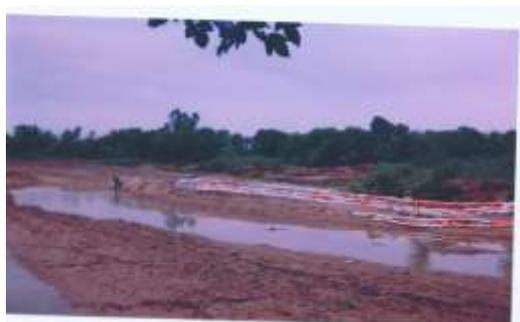
Plate 3: Row of sand bags across the main flow to control the shift of channel, a practice adopted by local people

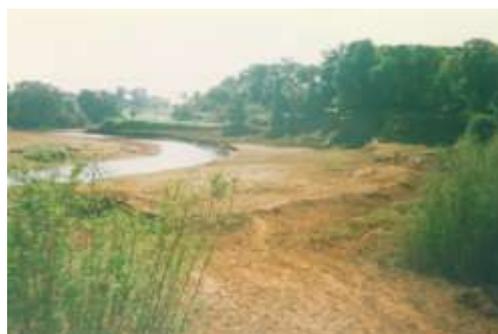
Plate 4: Right bank upper terrace excavated up to water level near confluence, river shifted to right

In this section channel is wide but near CS 70, located near the Umbraj highway bridge, the channel is very narrow. This location has escaped from excavation activity due to the Pune-Bangalore Highway Bridge. From the bridge downward, the line of trees clearly indicates the shift of the channel as shown in map, also marked by old channel. Near CS 75, left bank cutting in April 96 has been observed. Opposite to this location up to CS 80, the extraction activity have been noticed in the right side of the bank, more alluvium has been extracted in April 96 from this site. The average width of the channel is 200 m, but the channel gets reduced at the area of the confluence, where it was about 50-60 m. The scratching of alluvium from the bank/field up to the water level of river also identified between CS 80 and 85 during 1996 and 1997(plate 4). Same location also indicated the development of large lateral bar with coarser material along the left side of the river. During Jan96 and Apr 96, recent extraction activity of alluvium has seen along left bank near the confluence, which has extended to 150 m to the left side of the bank and with this regard CS 90 of Oct 2002 clearly shows the poorly excavated block up to the thalweg of river Krishna, that means totally scratched up to the water level.
